An Integrated Wind-Water Desalination Demonstration Plant for an Inland Municipality

Final Report

Ken Rainwater¹, Lianfa Song¹, Tom Lehman², and John Schroeder³
¹Water Resources Center, ²Department of Geosciences,
³Wind Science and Engineering Center (now National Wind Institute)
Texas Tech University, Lubbock, TX

City of Seminole
Tommy Phillips, City Administrator
302 South Main Street
Seminole, Texas 79360

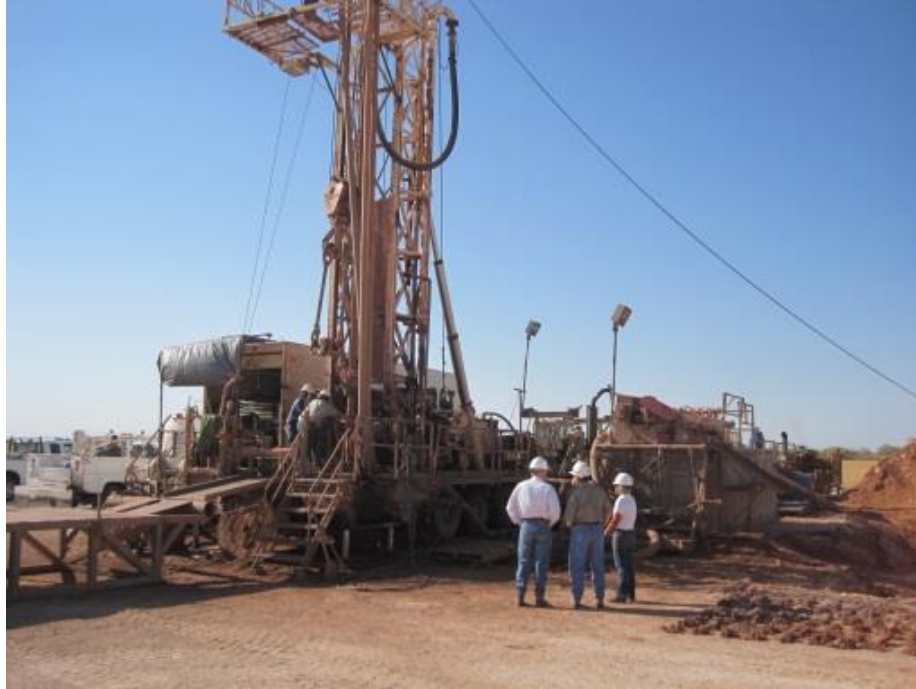
Figure 4. WTWWS drill rig and crew during drilling event

The drilling was completed during June 21 to July 7, 2011. Figure 4 is a photograph of the drill rig and crew on site. To protect the shallow Ogallala Aquifer, 12.25-in steel surface casing was placed and cemented in a 17.5-in hole to a depth of approximately 274 ft, terminating about 100 ft below the base of the Ogallala and the underlying Cretaceous layer. An 11-in hole was advanced below to a total depth of 1808 ft, and a 7-in steel casing was installed and cemented. Cirrus (2011) collected samples for the geologic log. The driller's log (State of Texas Tracking #259331) is provided in Appendix B. Cirrus (2011) provided a detailed geologic log based on the field observations of Dr. Judy Reeves, as well as the geophysical gamma and neutron porosity logs were run by E-P Wireline/Schlumberger. The logs were interpreted by Dr. Judy Reeves of Cirrus and Dr. Dennis Powers, another geologist who consulted with WTWWS on deep wells. Based on the cuttings and the geophysical logs, the most promising zones were noted from 540-650 ft (in the lower Cooper Canyon Formation with claystones interbedded with sands and gravels), 890-920 ft (in the lower Trujillo Formation with silts and siltstones interbedded with clays), and 1610-1770 ft (interpreted as within the Santa Rosa Formation based on sandstone and siltstone interbedded with clays). These three zones were perforated with two shots per ft. Figure 5 shows the completed well site.

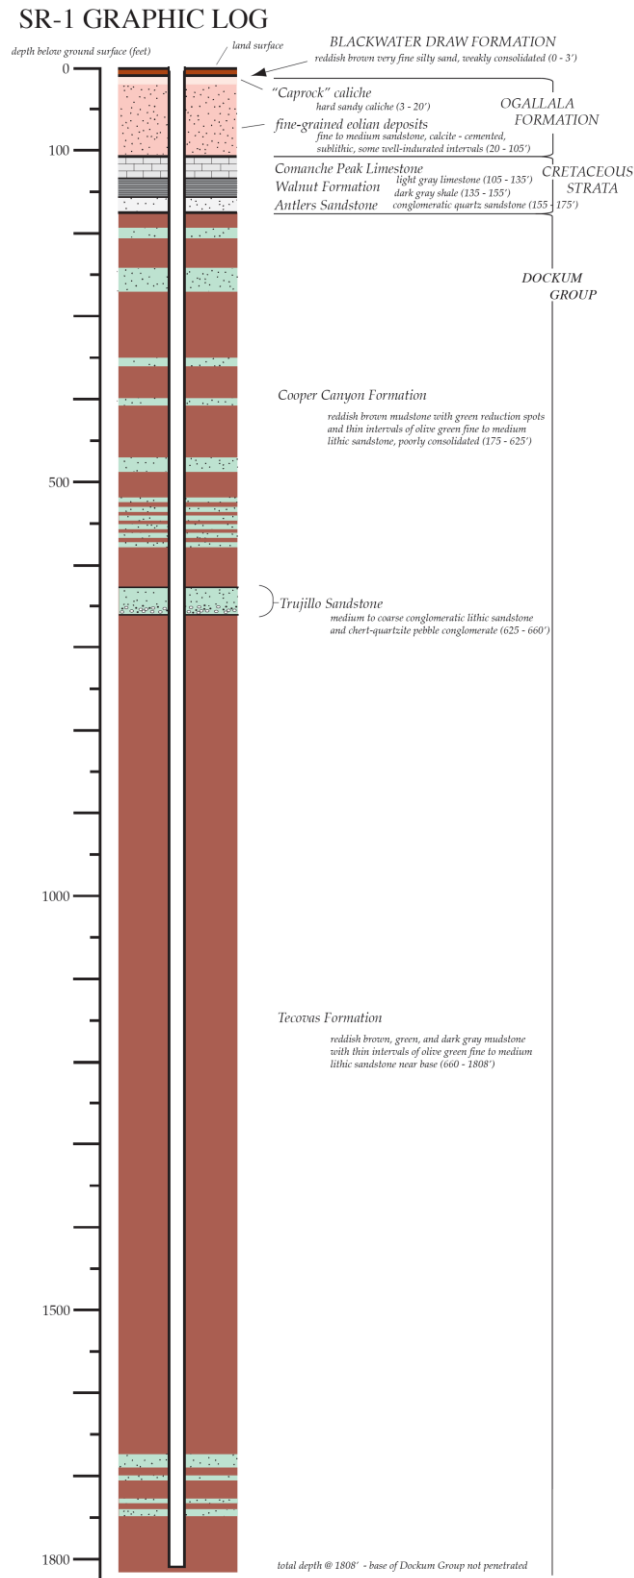
Figure 6. Simplified geologic log by Dr. Tom Lehman

Dr. Tom Lehman, an expert on the Dockum Formation in Texas and New Mexico (Lehman et al. 1992, Lehman 1994a, 1994b), also generated a simplified geologic log from his analyses of the cuttings samples provided by Cirrus. Dr. Lehman noted that his analyses of cuttings could have been affected by caving within the well during drilling. Figure 6 summarizes his descriptive log, and his verbal descriptions are included in Appendix A. His analyses indicated thin intermittent sand units from about 200 ft to 600 ft in the Cooper Canyon Formation in the upper Dockum, less likely to be productive. The Trujillo Sandstone in the middle Dockum appeared to have more coarse-grained and conglomeratic materials at 625 ft to 660 ft, which may be productive. He described the Tecovas Formation in the lower Dockum as having virtually no sand above the 1700 ft depth, and the sandy intervals below were lithic sands, not the quartzarenite and chert conglomerates that are typically associated with the Santa Rosa Sandstone. While the sandy intervals can provide water, the zone is not technically the Santa Rosa. He concluded that either the Santa Rosa was not present or the well was not deep enough to penetrate that sandstone. The well was terminated within the Dockum, so it is probably best that we refer to our well as a Dockum well, and be pleased that we have producible water. As noted by Bradley and Kalaswad (2003), the productive part of the Dockum is often referred to locally as Santa Rosa without consideration of the sand materials.

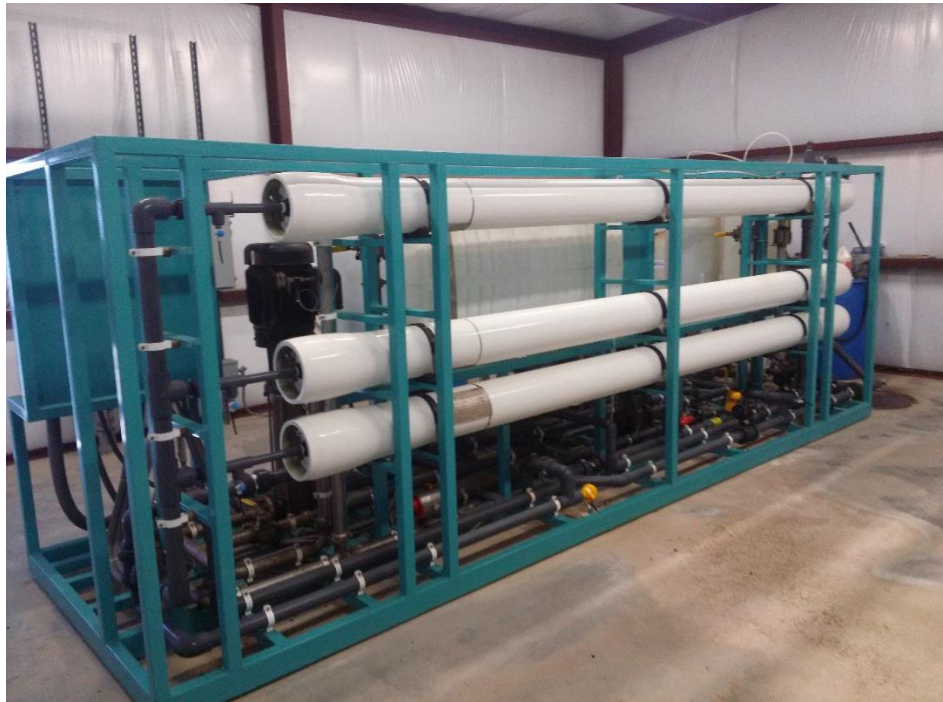
Figure 8. RO skid in place at the demonstration site

PSC staff engineers assisted with the procurement of the RO system for the demonstration project based on their previous experience with similar treatment projects and TCEQ regulatory requirements. The general goal of the specification was a complete operational skid-mounted RO system to treat an inflow of at least 50 gpm of brackish water to meet the TCEQ's primary drinking water standards, with pretreatment capability for cartridge filtration, pH adjustment, and antiscalant addition. The target recovery factor was at least 70 percent with a salt rejection rate of 95 percent and minimum membrane life of two years. The RO system was purchased from Crane Environmental of Venice, Florida, in December 2010 with TTU DOE funds for \$85,169 plus \$5,500 for spare parts. The RO system model was an EPRO 12x840 with clean-in-place capability and two chemical dosing systems for antiscalant and pH adjustment. The Dow Filmtec LE RO membranes were 8-in diameter by 40-in long elements in a two-stage configuration with the first array containing two sets of four elements and the second array holding one set of four elements. A variable frequency drive (VFD) controlled the high pressure pump. A touch-screen monitor provided access to the electronic controls for data outputs, alarm settings, recycle flow settings, and flush scheduling. Various flow, temperature, pH, and conductivity meters collected the displayed data. One of the few manual valves was used to control the concentrate recycle flow. The antiscalant was CC 4200, a polymer-based chelating agent input through one of the two chemical dosing system. Acid could be added to the antiscalant tank, or input from the second chemical dosing system. A Myron-L test meter, with associated stock standard solutions, allowed direct measurement of pH, conductivity, and TDS from grab water samples from the various ports on the system. Figure 8 shows the RO skid inside the RO building. The two lower white pipes each held four elements and make up the first array, while the upper white pipe held the four elements of the second array.

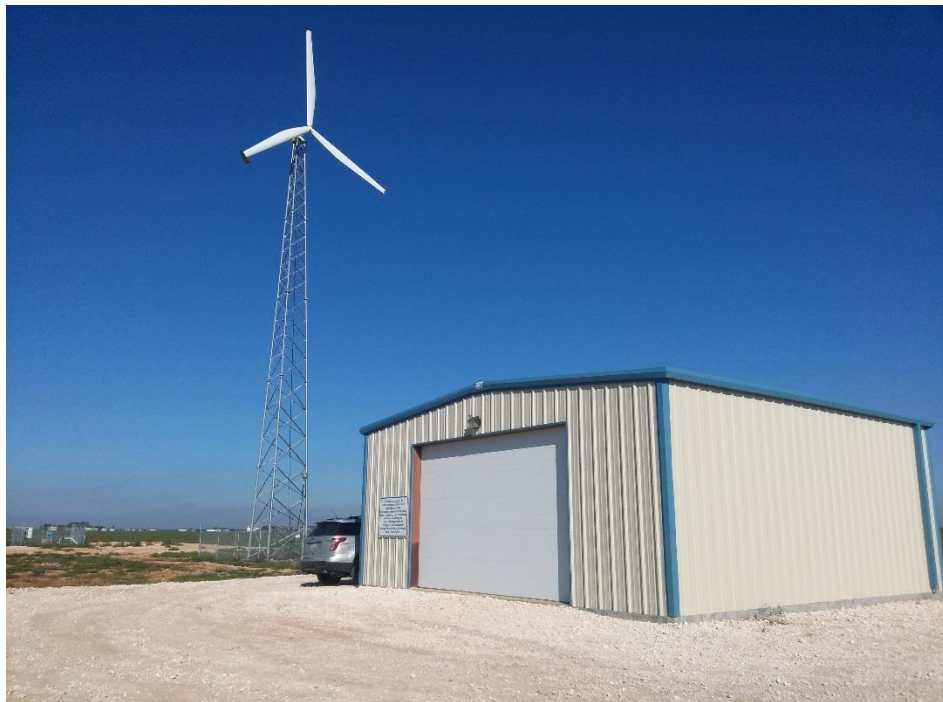
Figure 9. RO building, wind turbine, and well site

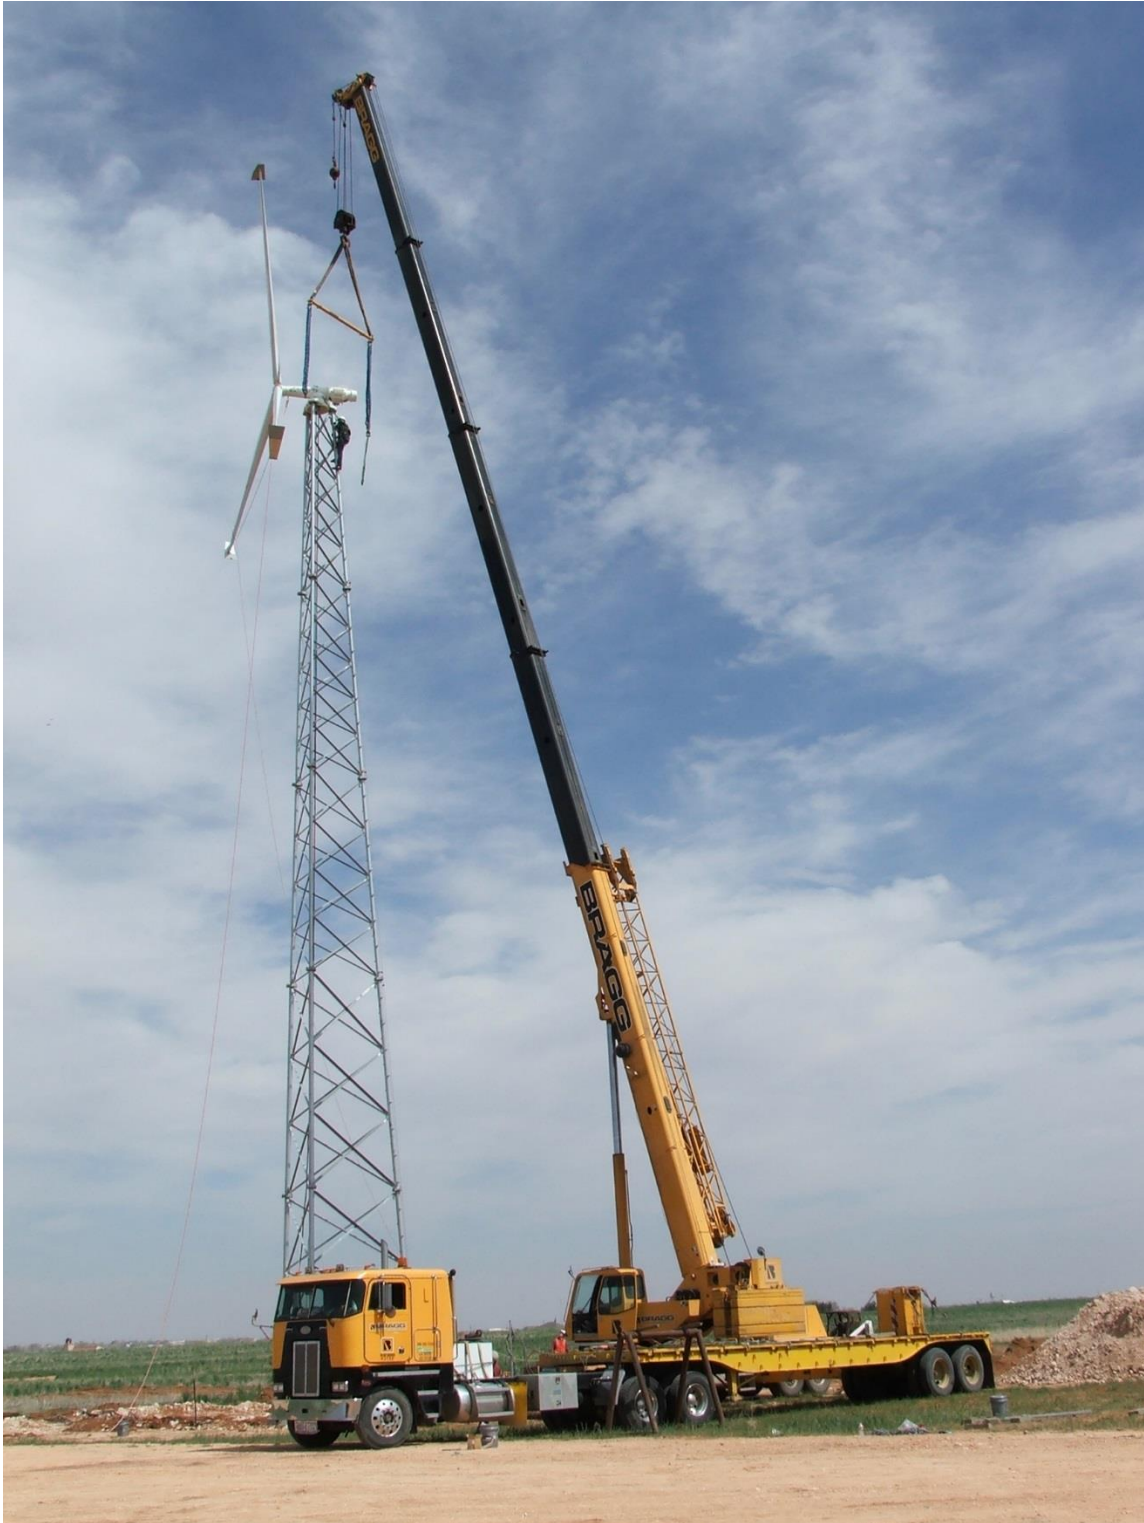
Figure 11. Assembly of the 50-kW wind turbine

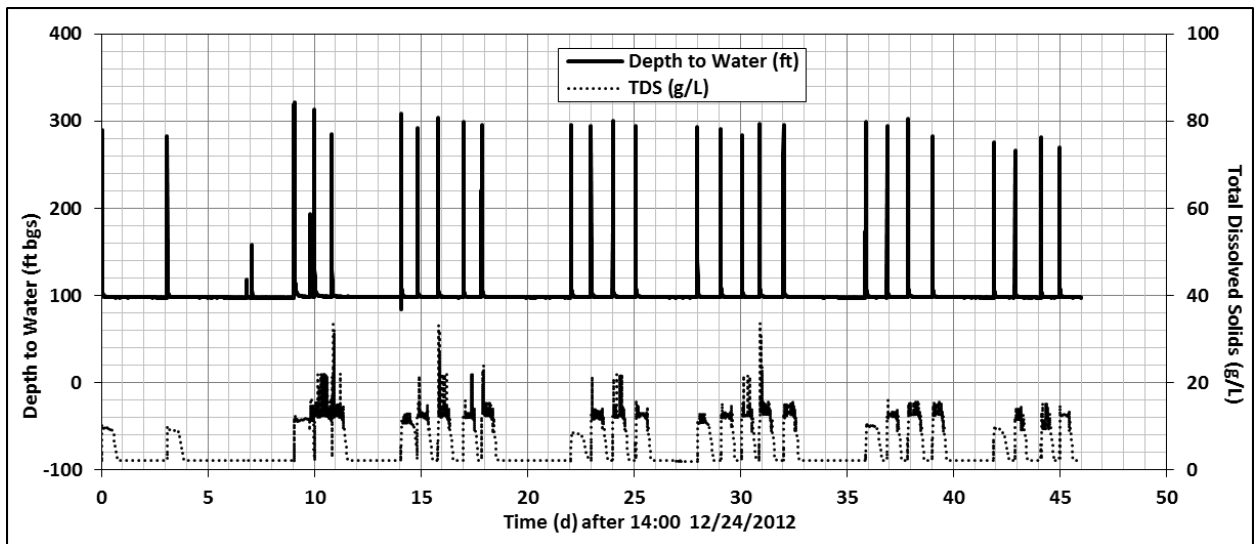
Figure 13. Depth to water and TDS from Aqua Troll for December 24, 2012 to February 10, 2013

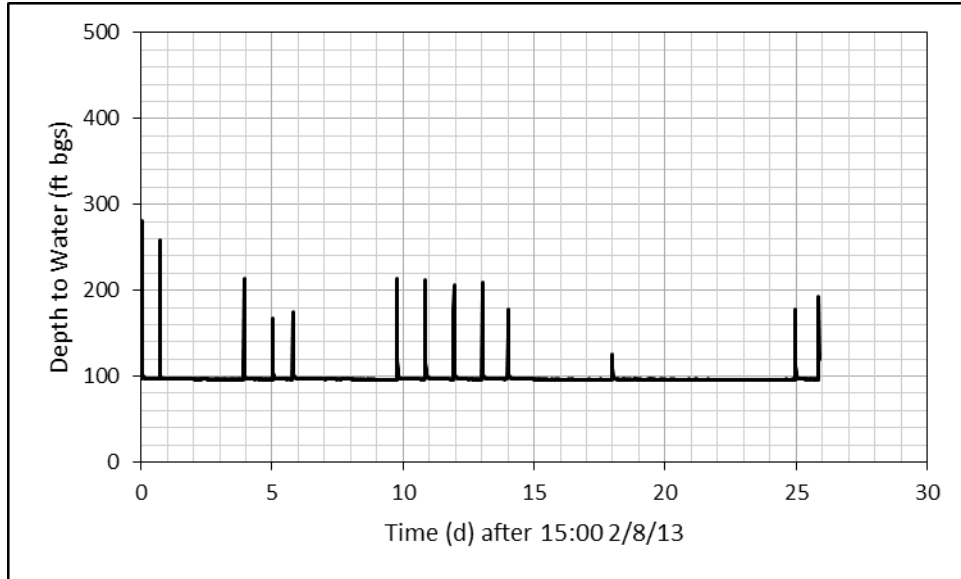
Figure 14. Depths to water for February 8 to March 6, 2013

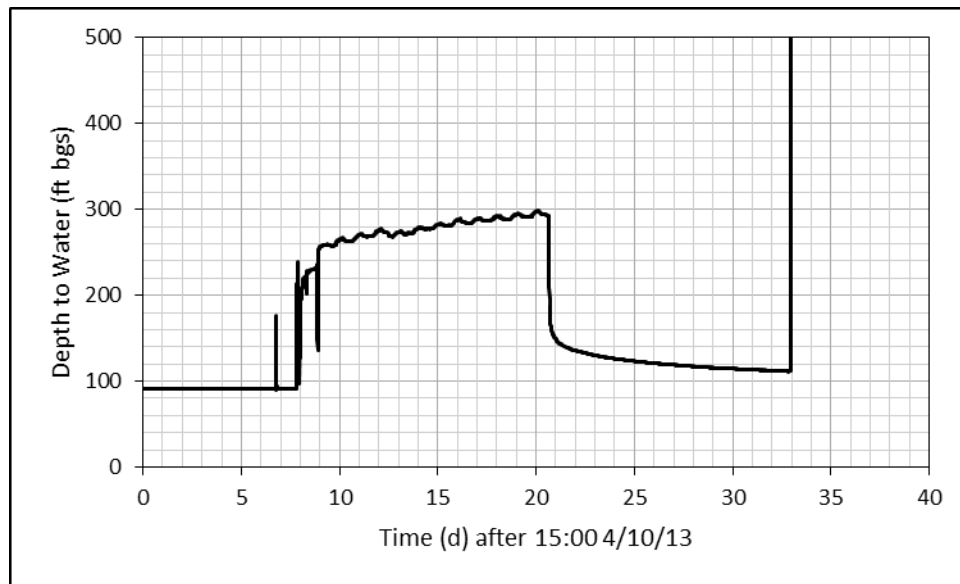
Figure 16. Depths to water for April 10 to May 13, 2013 (well motor failed on May 1, transducer removed May 13)

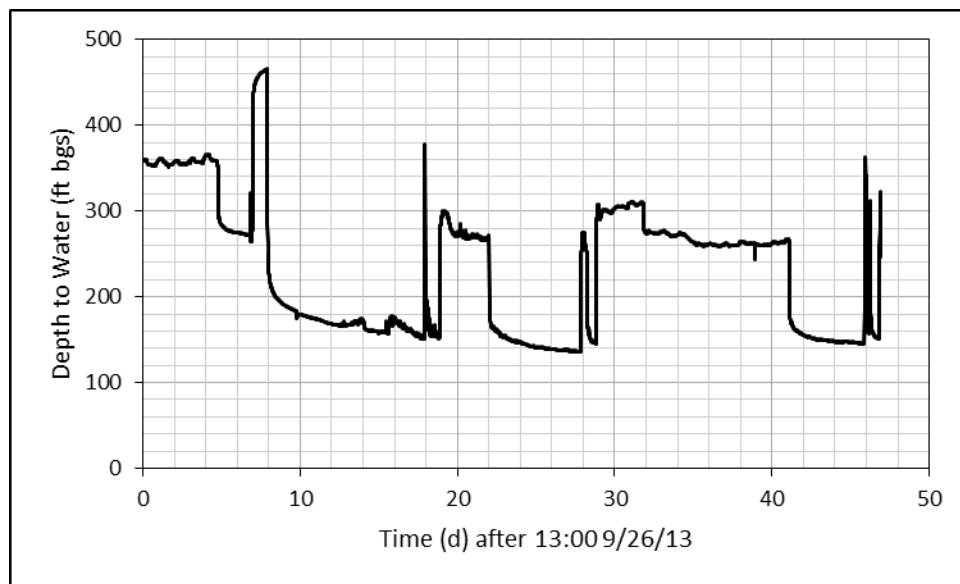
Figure 17. Depths to water for September 26 to November 12, 2013

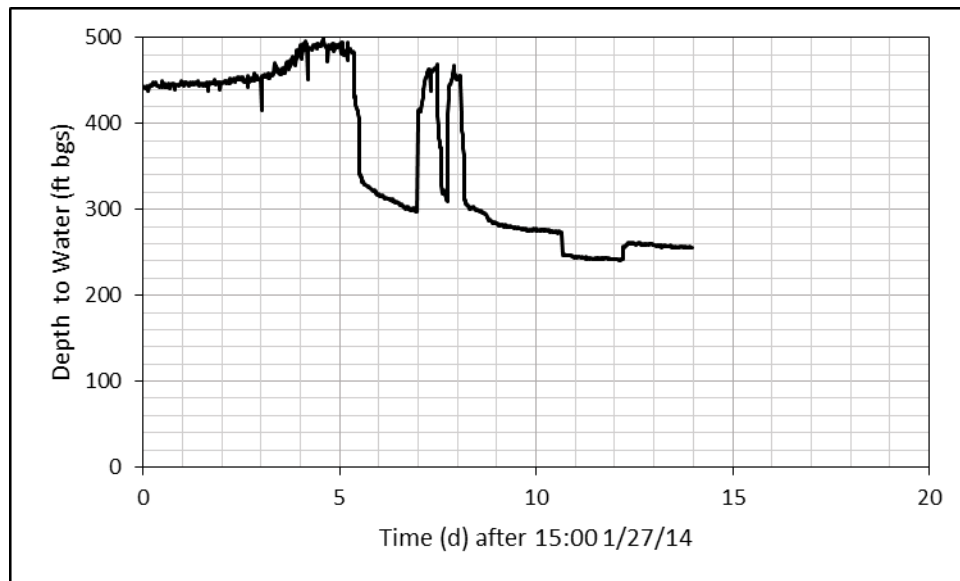
Figure 19. Depths to water for January 27 to February 10, 2014 (well flow set at 65 gpm prior to February 2, then reduced to 55 gpm, followed by down time; transducer failed on February 14)

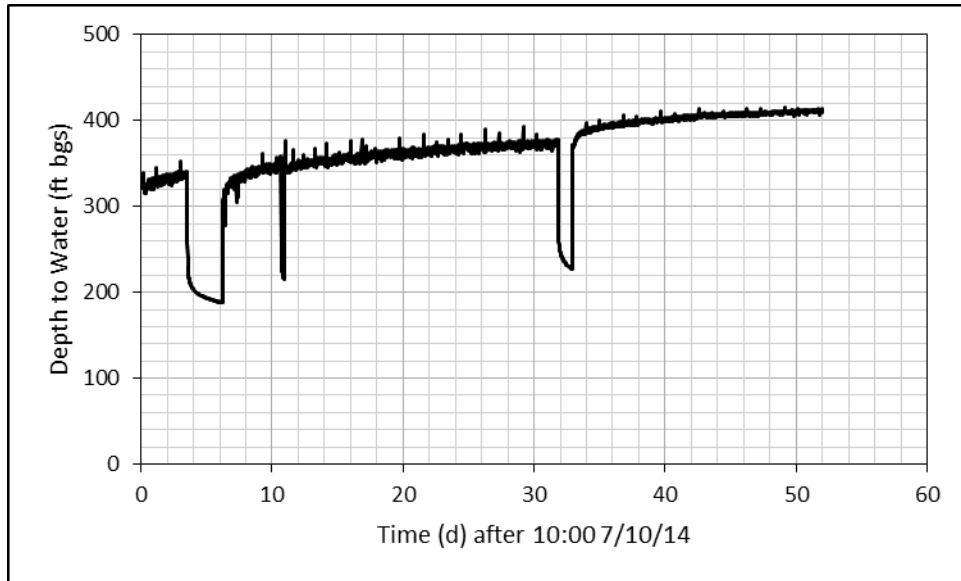
Figure 20. Depths to water for July 10 to August 31, 2014

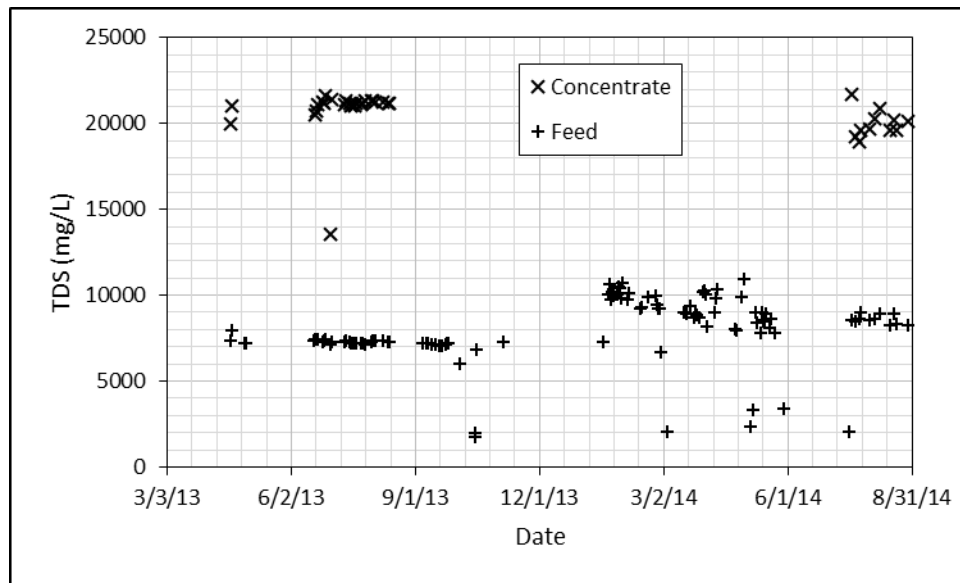
Figure 23. Comparison of feed and concentrate TDS levels

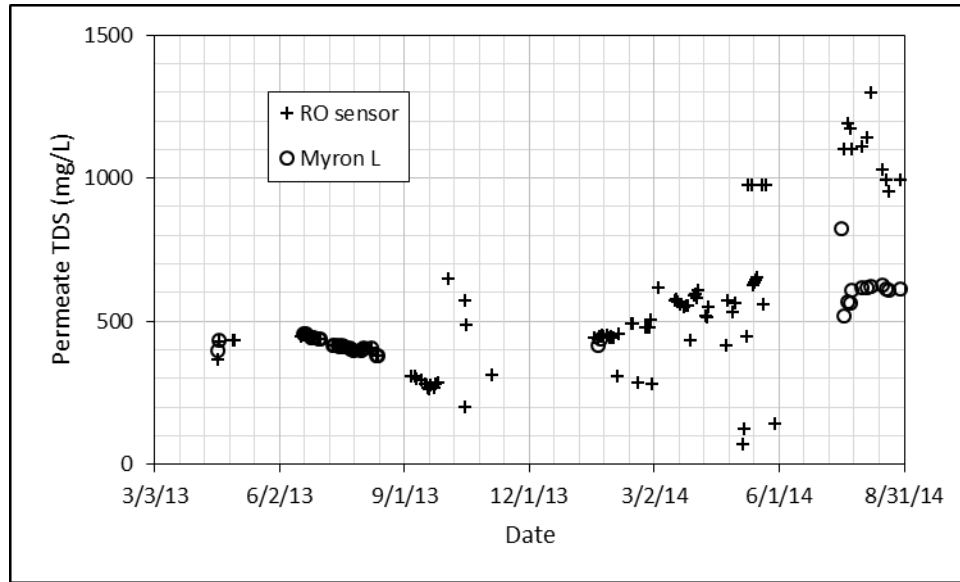
Figure 24. Comparison of permeate TDS from RO system sensor and Myron-L meter

concentrate flow indicated malfunctioning of the concentrate flow meter, which the City staff could repair by removing, cleaning, and replacing the flow meter. Recycle flow refers to concentrate recycle that was added to the total feed to manage the water flux across the membranes. The zero values toward the end of the demonstration period were likely due to sensor failure. Figure 23 displays the TDS levels in the feed water and the concentrate produced by the RO system. The permeate TDS values are shown separately in Figure 23 as a different flow rate scale was necessary. In Figure 24, there were some dates on which values of permeate TDS were recorded both the RO system sensor and the Myron-L meter. In the early months of

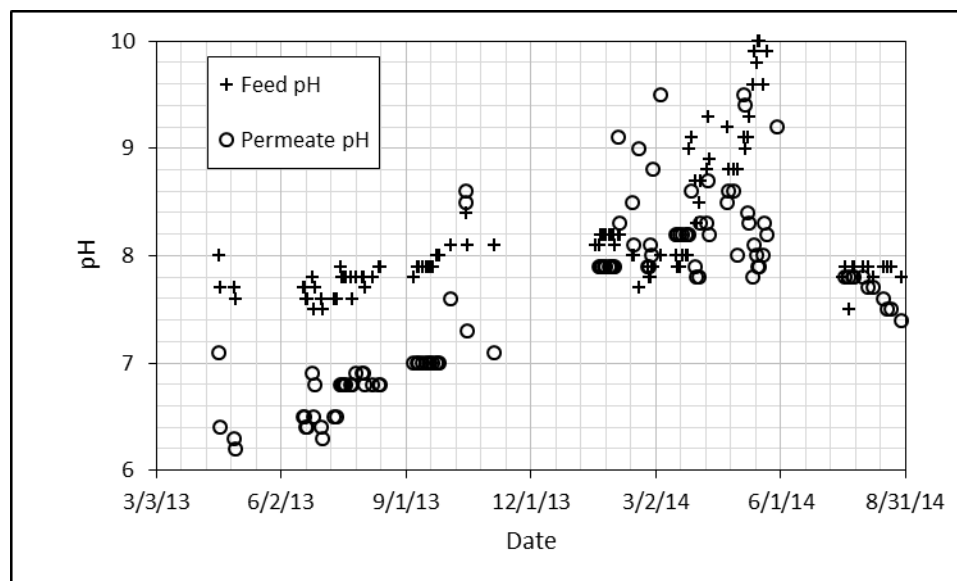
Figure 28. Comparison of feed and permeate pH levels

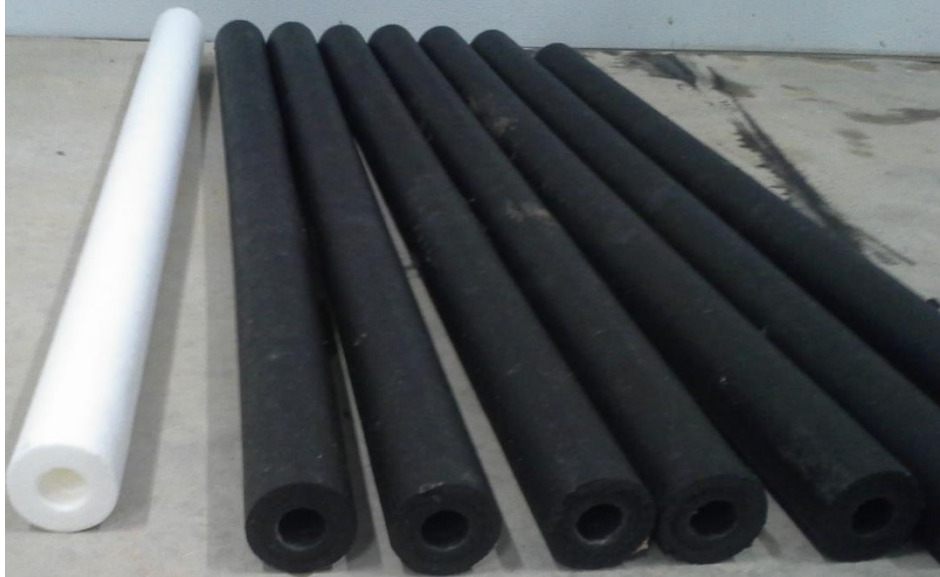
Figure 29. Prefilters removed on January 13, 2014 (new cartridge on left for comparison)

fouled. The system had been idle for two months, and the prefilters and membranes had a hydrogen-sulfide-type odor. Figures 29 and 30 show their photographs of the prefilters and membranes that day. The Worth team recommended autopsies of the most upstream element, one of the most downstream elements, and one of the prefilter cartridges. The results of those analyses are presented in the next subsection.

The cartridge filter was covered in a heavy layer of brown-colored foulant. Brown discoloration was also noted on the interior of the filter. LOI testing indicated the foulant from the cartridge filter was composed of 8.8 percent volatile organic material and 91.2 percent inorganic material. SEM and T-EDXA analyses determined the largest inorganic constituent of the foulant was iron at 71.30 percent. The remaining inorganic constituents were silicon (11.97 percent), calcium (4.57 percent), sulfur (3.70 percent), chlorine (2.95 percent), aluminum (2.70 percent), potassium (2.06 percent), manganese (0.39 percent), titanium (0.28 percent), and magnesium (0.02 percent). FTIR analysis of the foulant removed from the cartridge filter indicated it was mostly alumino-silicate clays, obviously from the Dockum clays, with small amounts of carbohydrates and polysaccharides.

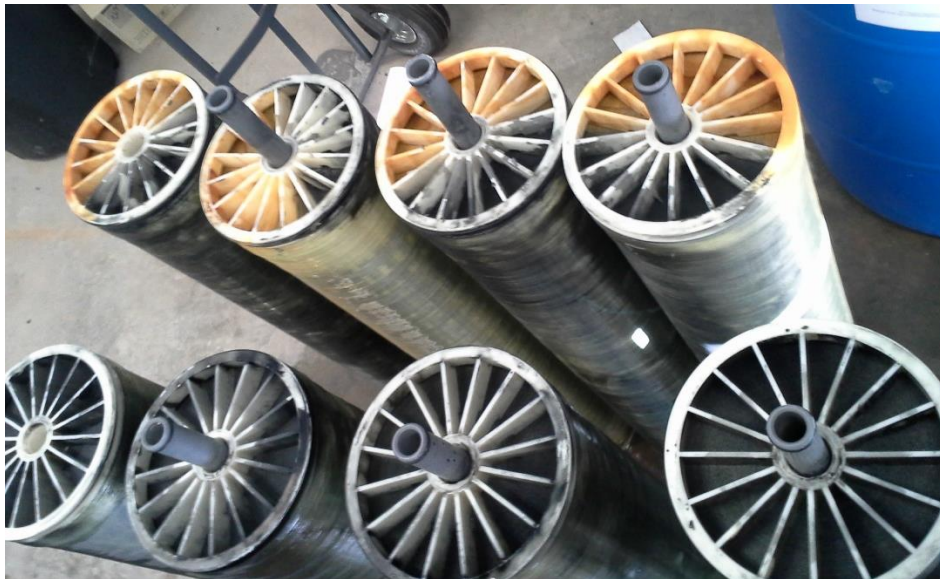
Figure 30. Membrane elements removed on January 13, 2014 (upper row Array 2, lower row Array 1)

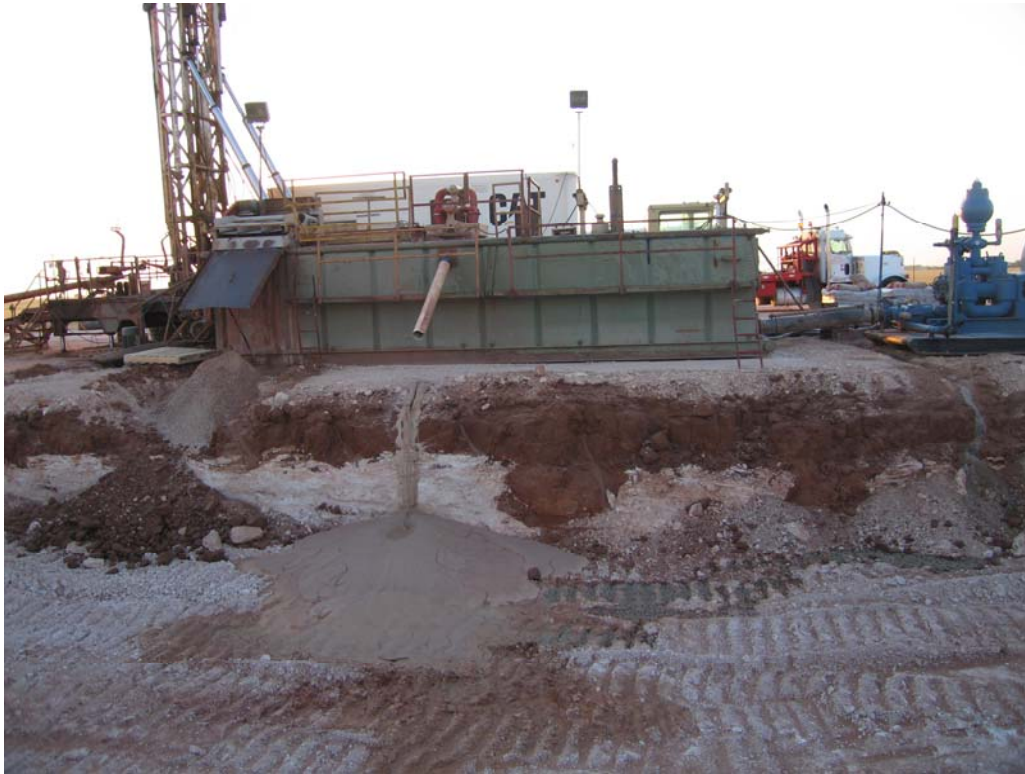
**PHOTO NO. 1
DESCRIPTION:**

"Flower pot" structures in the side of the mud pit. Reddish brown silty sand of the Blackwater Draw formation overlies the Ogallala caprock caliche. The flower pot structures are the silty sands incised into the top of the caliche zone.

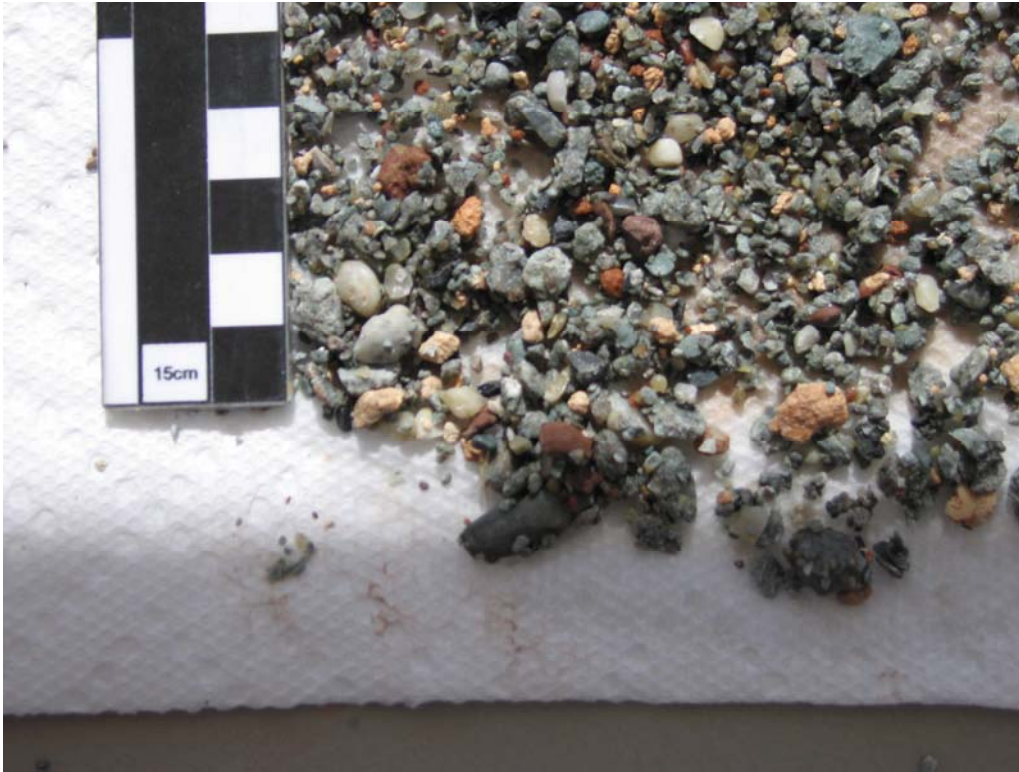
PHOTO NO. 3
DESCRIPTION:

Gravel section at a depth of 640' bgs. Each unit on the right side of the scale is equal to 1cm.

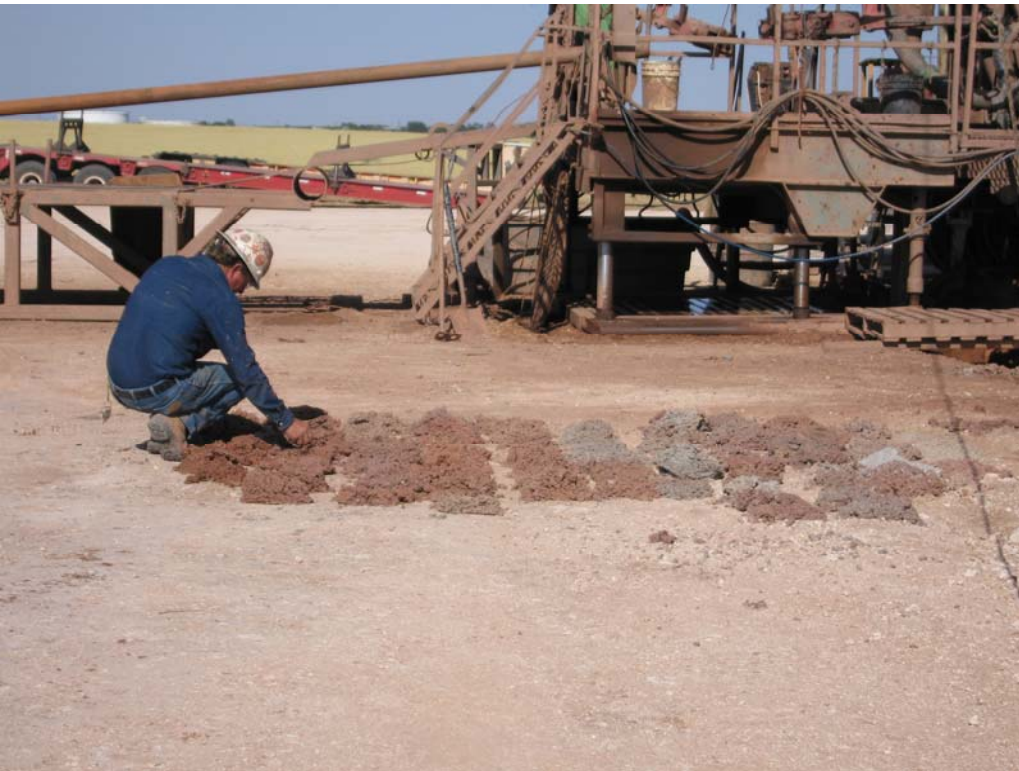
PHOTO NO. 4
DESCRIPTION:

The driller laid out soil samples collected at 10' intervals from the shaker and prepared the driller's log based on these cuttings.

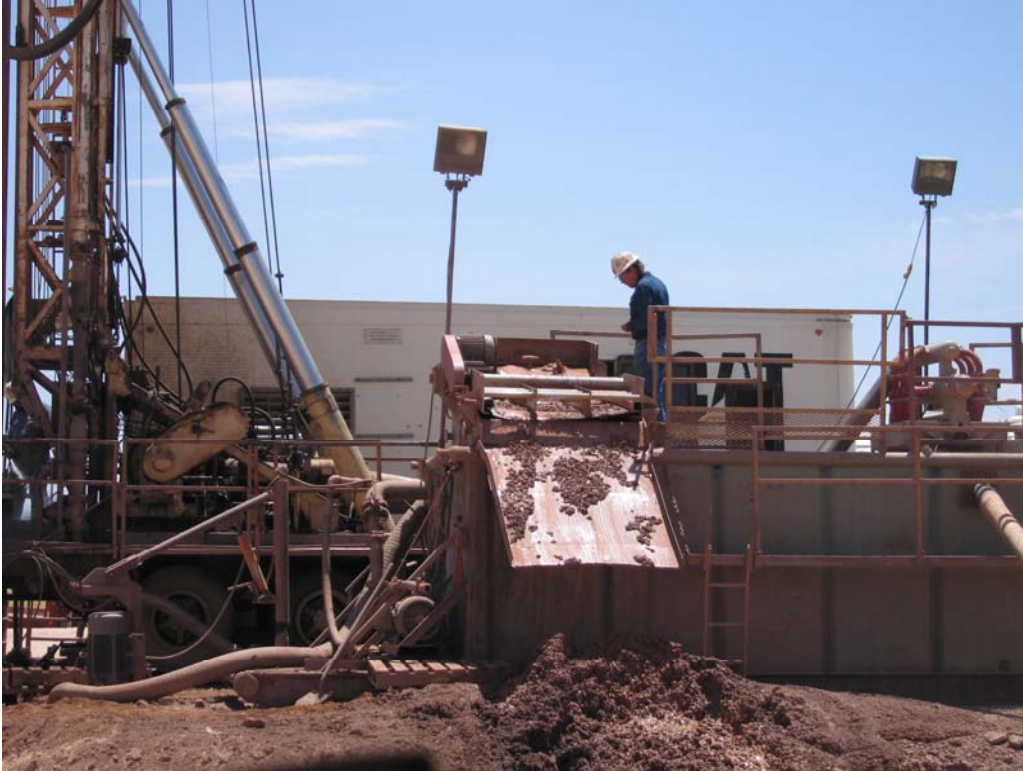
PHOTO NO. 5
DESCRIPTION:

Cuttings collected from the "shaker" were used for preparation of the geologic log. The "fines" are separated out by the shaker, thereby biasing the soil samples. Sandy zones (i.e., fines) were noted based on the volume of sand from the sand separator.

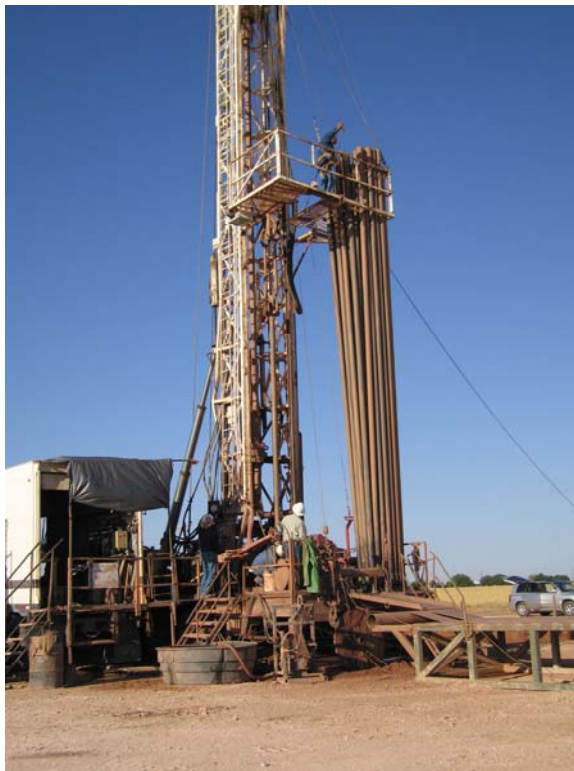
PHOTO NO. 6
DESCRIPTION:

Near the bottom of the hole, approximately 60 drill stems (shown in the rack) were tripped in and out of the hole each day. The drill stems are approximately 30 feet in length.

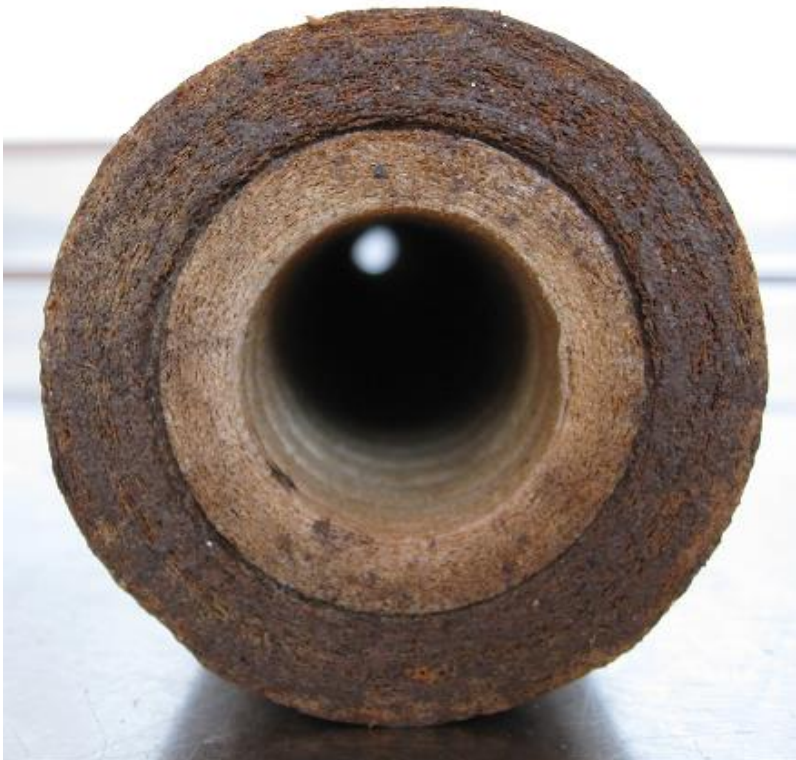
Figure 2. End of cartridge filter, note the light brown discoloration of the interior.

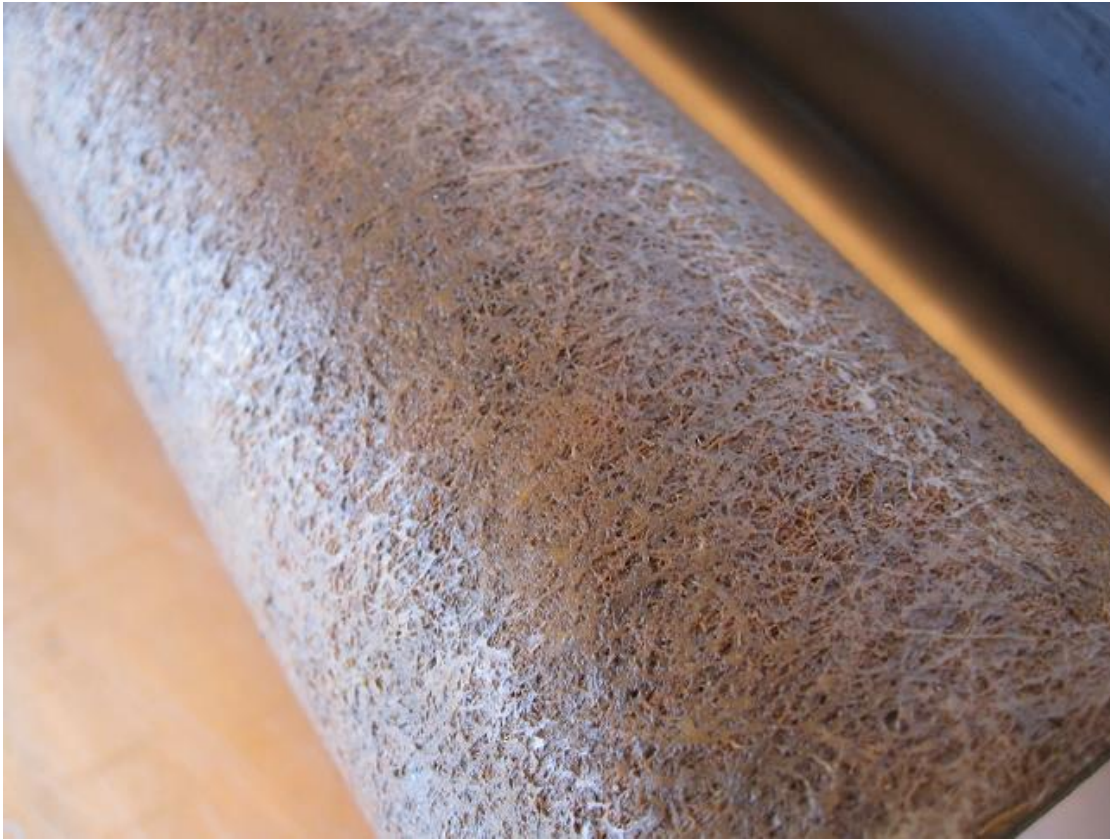
Figure 3. Close-up of cartridge filter surface, note the heavy coating of brown foulant.

The cartridge filter was covered in a heavy layer of brown colored foulant (Figures 1-3). Brown discoloration was also noted on the interior of the filter (Figure 2). The filter was soaked in DI water overnight and the foulant was collected for Loss on Ignition (LOI), Scanning Electron Microscopy (SEM), Targeted-Energy Dispersive X-Ray Analysis (T-EDXA) and Fourier Transform Infrared Spectroscopy (FTIR).

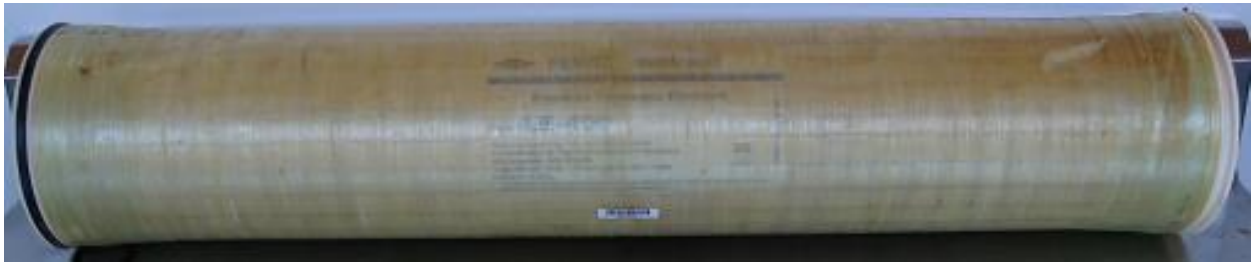
Figure 1. Element F5375550 as received.

Element F5375550 was examined, the fiberglass shell, ATD's, permeate tube and brine seal were all intact and in good condition (Figures 1-3). Orange deposition was found on the fiberglass wrap of the element. Significant foulant build-up was found on the feed end ATD (Figure 2). There were no significant odors detected from the membrane. Telescoping was not observed to have occurred to the RO element.

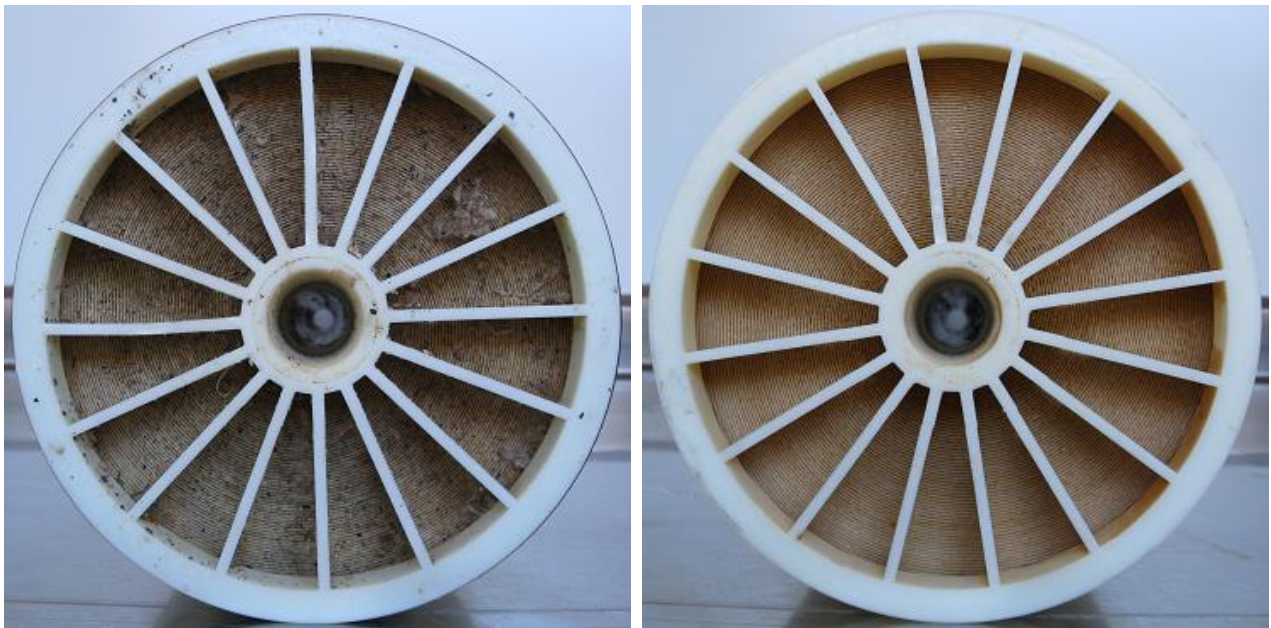
Figure 2. Feed-end of element F5375550, note the foulant build-up.

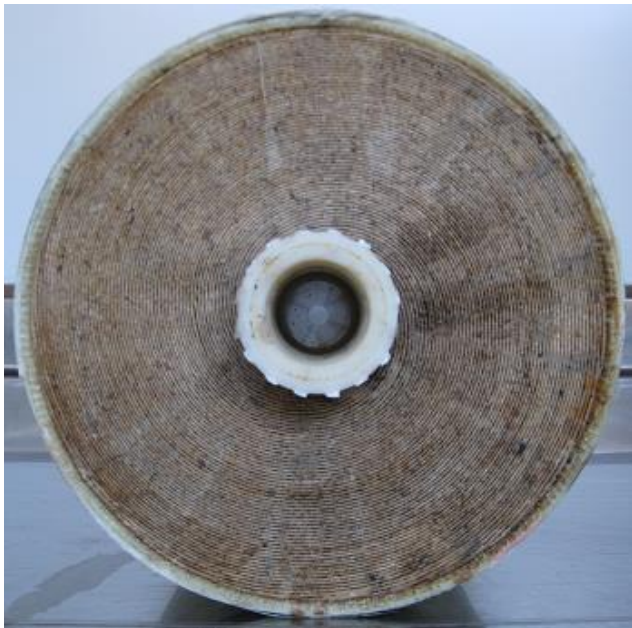
Figure 4. Feed-end of element F5375550.

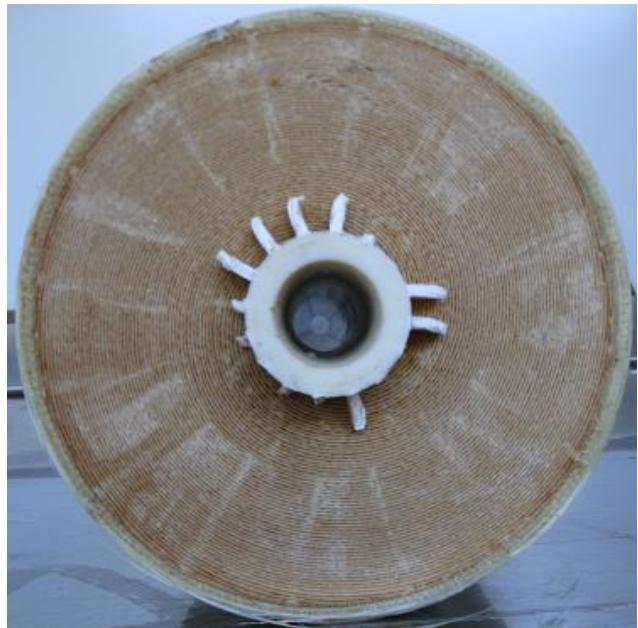
Figure 5. Concentrate-end of element F5375550.

Once the ATD's were removed, the scroll ends of the membrane leaves were examined for the presence of colloidal particles, biofouling, feed spacer extrusion, membrane gapping, etc. There was foulant build-up on the feed scroll end of the element. Dissection of the element revealed a coating of orange colored foulant on the membrane surface (Figures 6-7). Staining of the membrane backing material was found on several of the leaves (Figure 8). The integrity of the glue lines and channel spacer netting material was good. Samples of foulant were removed for Loss on Ignition (LOI), Scanning Electron Microscopy (SEM), Targeted- Energy Dispersive X-Ray Analysis (T-EDXA), and Fourier Transform Infrared Spectroscopy (FTIR).

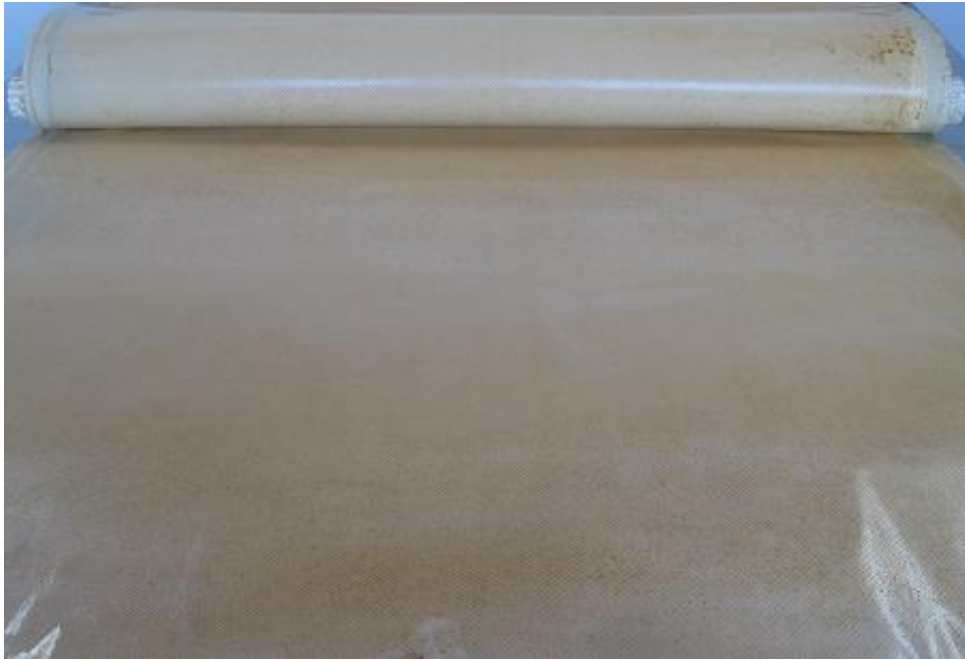
Figure 6. Element F5375550 unrolled.

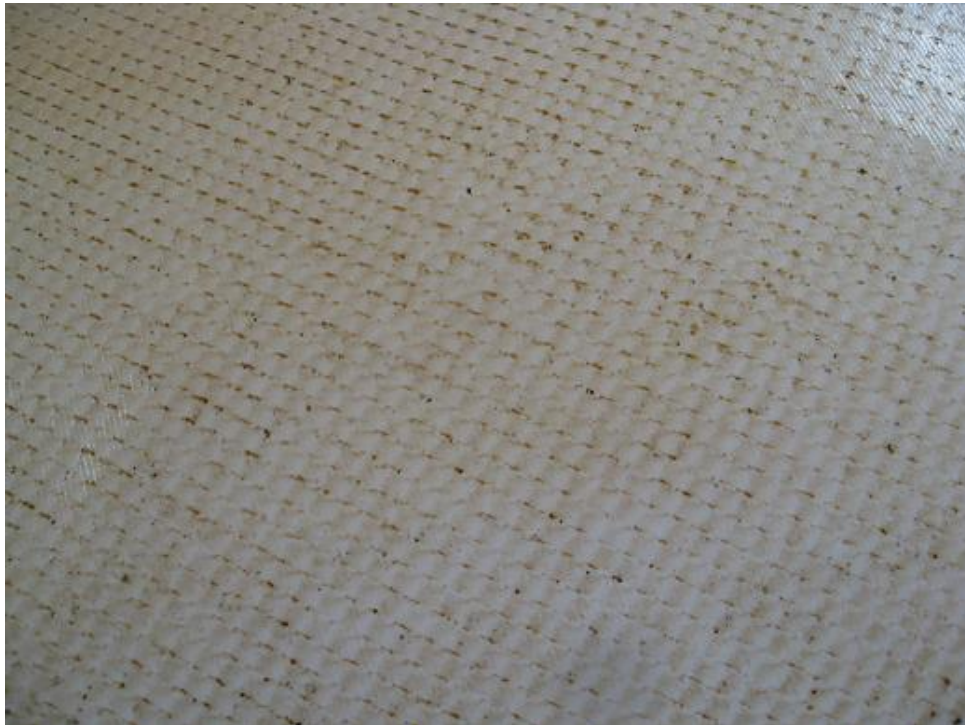
Figure 7. Close-up of the membrane surface from element F5375550.
