An Integrated Wind-Water Desalination Demonstration Plant for an Inland Municipality

Final Report

Ken Rainwater¹, Lianfa Song¹, Tom Lehman², and John Schroeder³
¹Water Resources Center, ²Department of Geosciences,
³Wind Science and Engineering Center (now National Wind Institute)
Texas Tech University, Lubbock, TX

City of Seminole
Tommy Phillips, City Administrator
302 South Main Street
Seminole, Texas 79360

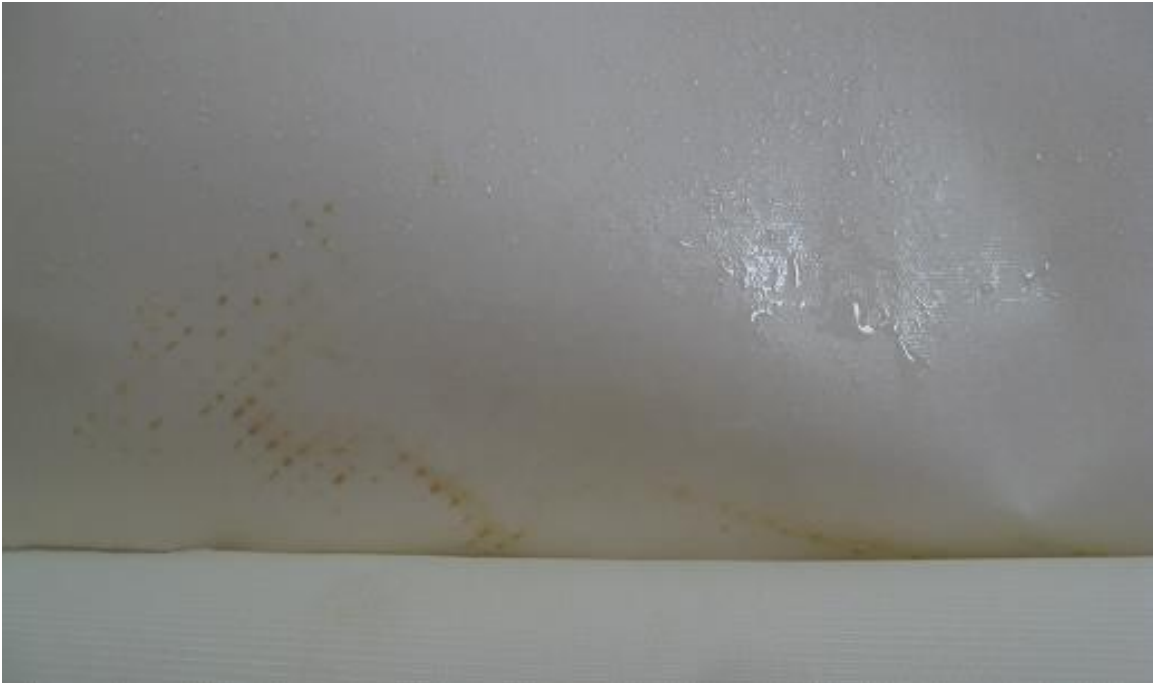
Figure 8. Close-up of the membrane backing material from element F5375550.

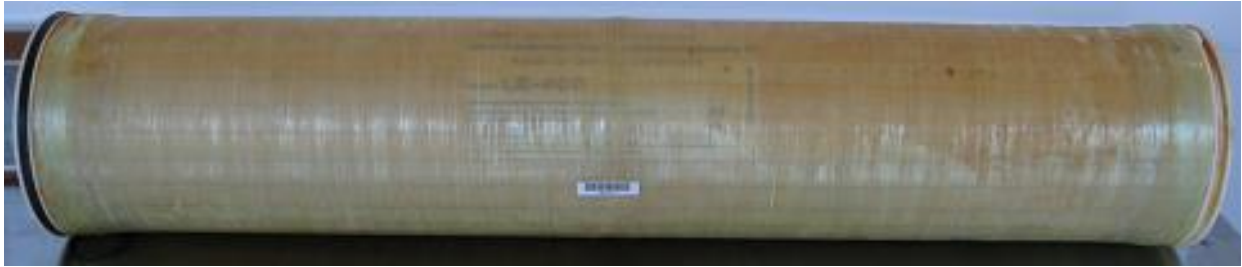
Figure 1. Element F5375511 as received.

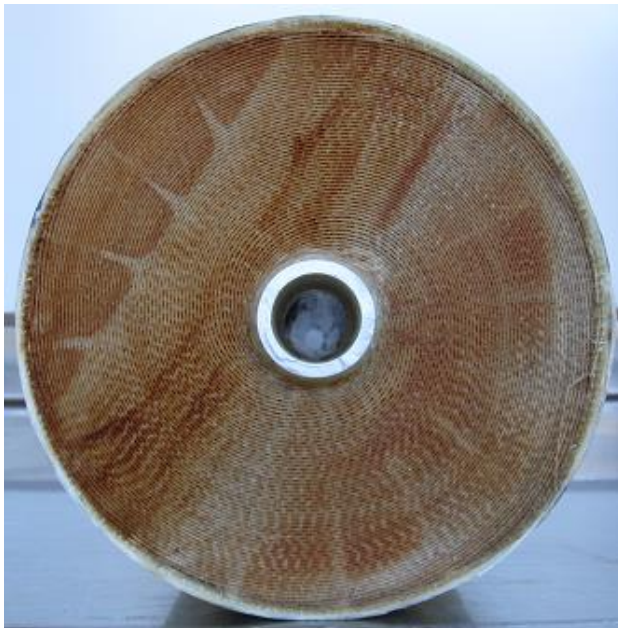
Figure 4. Feed-end of element F5375511.

Once the ATD's were removed, the scroll ends of the membrane leaves were examined for the presence of colloidal particles, biofouling, feed spacer extrusion, membrane gapping, etc. There was orange foulant on both the feed and concentrate scroll end of the element. Dissection of the element revealed a coating of a crystalline foulant and orange discoloration on the membrane surface. The integrity of the glue lines and channel spacer netting material was good. Samples of foulant were removed for Loss on Ignition (LOI), Scanning Electron Microscopy (SEM), Targeted- Energy Dispersive X-Ray Analysis (T-EDXA) and Fourier Transform Infrared Spectroscopy (FTIR).

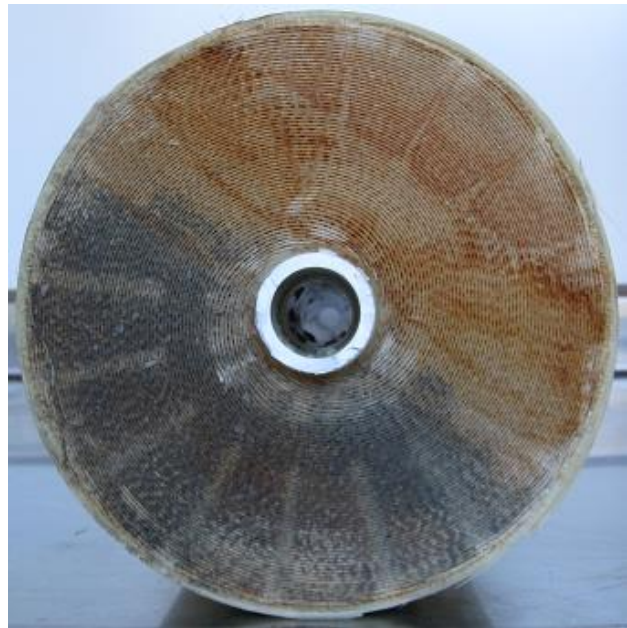
Figure 5. Concentrate-end of element F5375511.

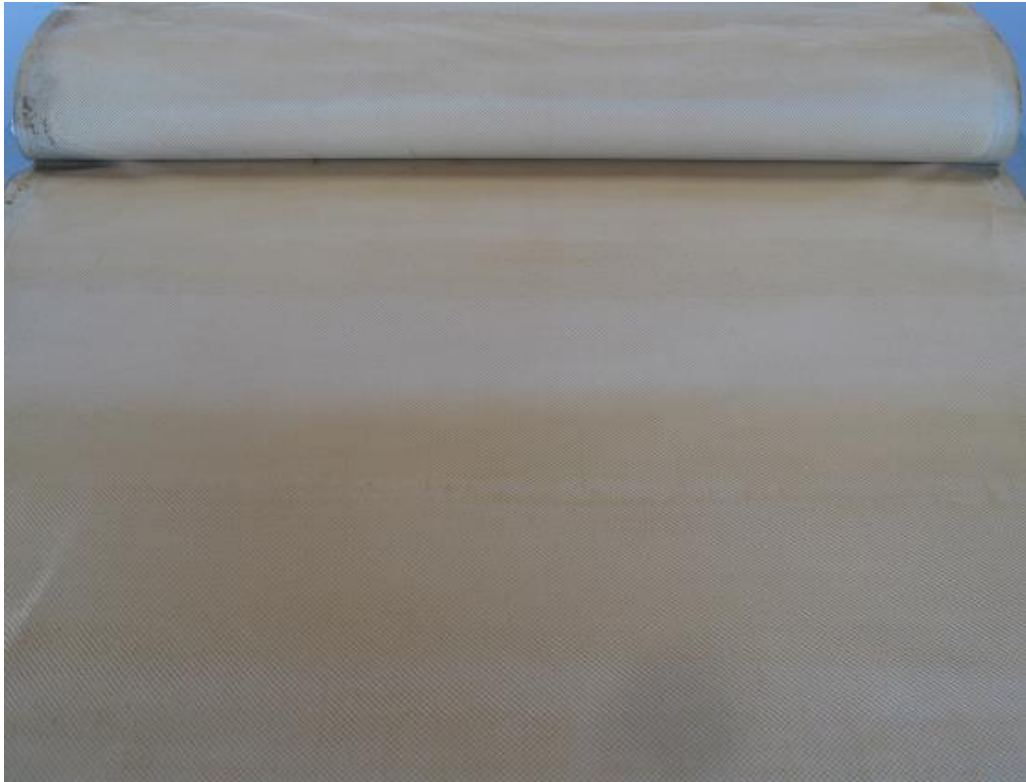
Figure 6. Element F5375511 unrolled.

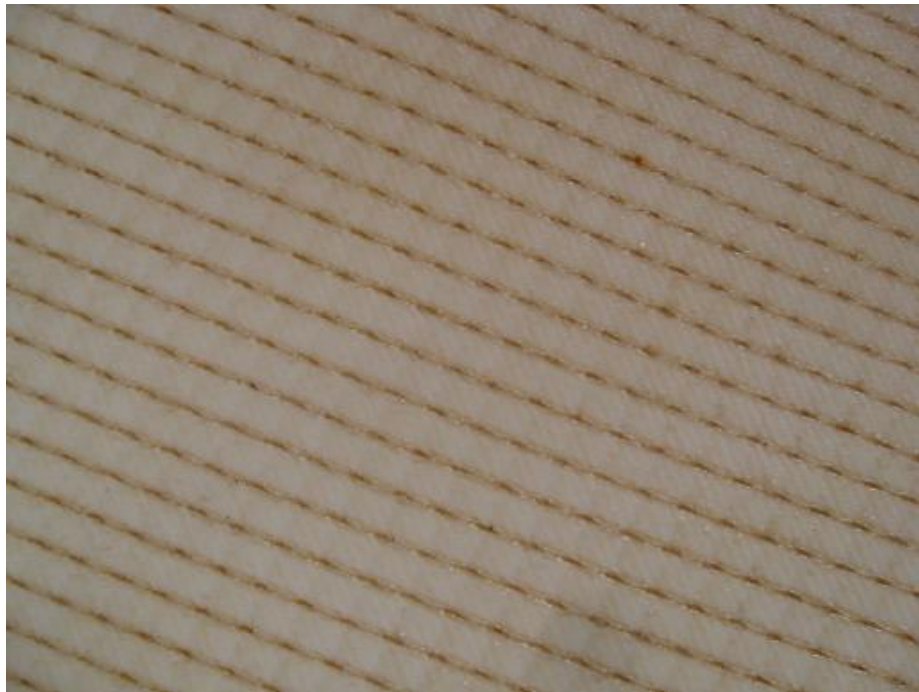
Figure 7. Close-up of the membrane surface from element F5375511.
